20 003 000 **SENTOSA PILLAR TAP**

## 20 003 000 SENTOSA PILLAR TAP

### SPARE PARTS, Januari 1993 – now

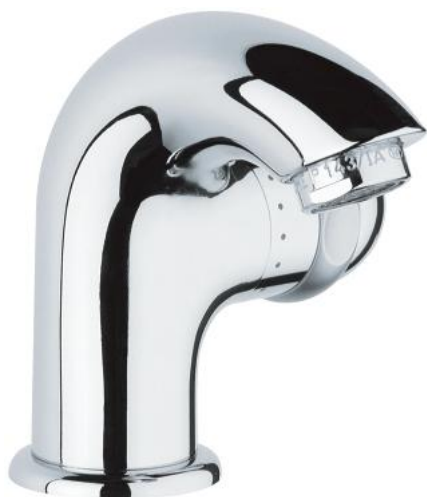
**PRODUCT DESCRIPTION**

- Colour: chrome
- ceramic headpart 1/2", 180°
- cast spout with Mousseur
- with small handle
- marking: blue
- GROHE Long-Life finish
